Nikau Contractors Limited  
Patea Freezing Works Remediation  
Monitoring Programme Report  
Technical Report 2010–70

February 2011

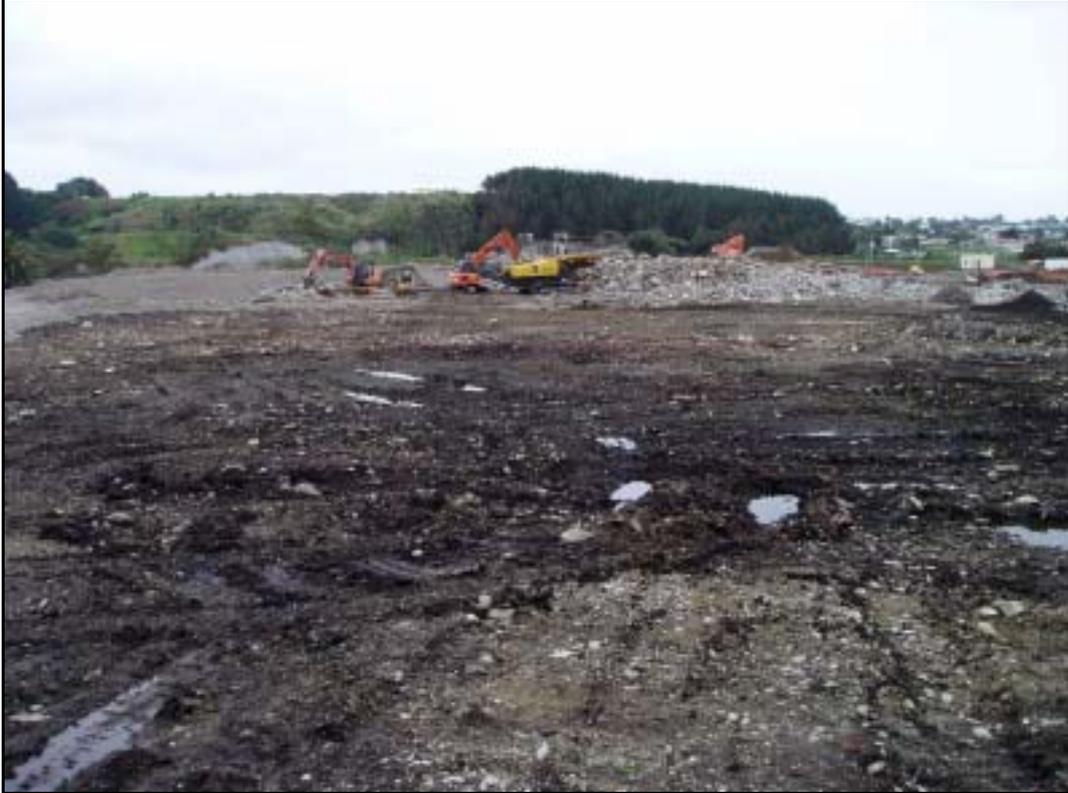
**Photograph 2** View from east to west on 3 May 2010

The site was neat and tidy, demolition work was nearly complete, with site restoration and reinstatement yet to be completed. There was no discharge off site after recent rain during the weekend. There were no dust issues arising as result of works. The site was secure and well managed.

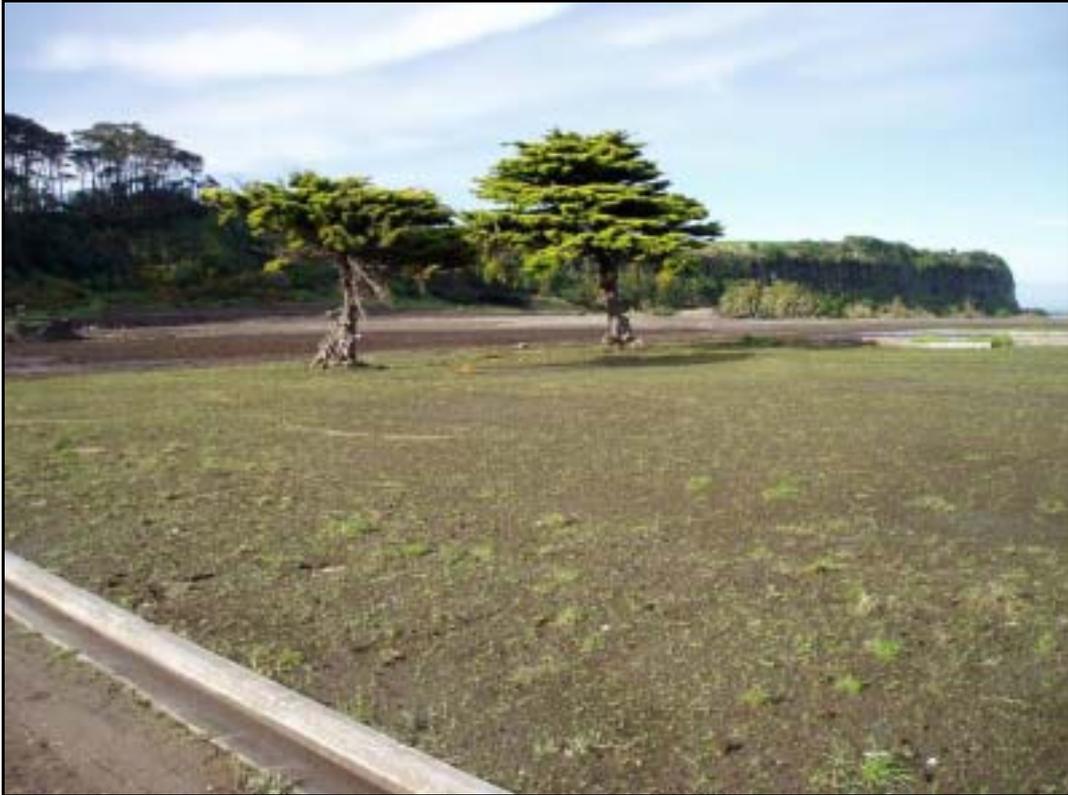
**Photograph 3** Eastern end of the site on 28 June 2010

Inspection undertaken after a period of prolonged rainfall. There was no evidence of any contaminated material left on site. The removal and clean up had been completed. Site contouring was almost complete, but final topsoil overlay and regrassing was planned for Oct/Nov. There was no evidence of stormwater contamination, nor discharge of any dust particulate off site. The site clean up was nearing completion as a result of extensive and thorough works carried out by Nikau.

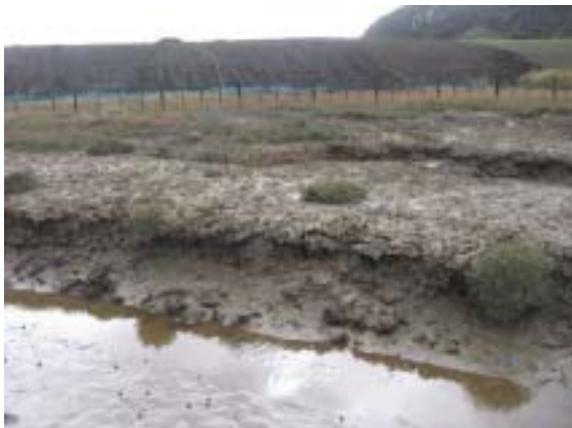
The upper mud flats contained a variety of different types of plants (Photograph 1 and 2).

**Photograph 1** Mud Flats adjacent to rehabilitated Freezing Works site at Patea showing several shrubs growing 5-8-10

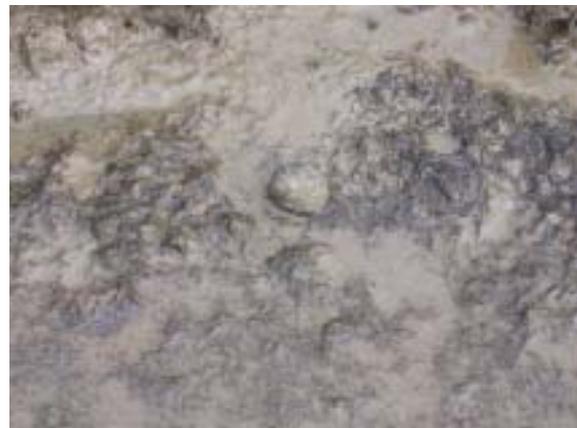
**Photograph 2** Mud Flats adjacent to rehabilitated Freezing Works site at Patea showing plant life 5-8-10

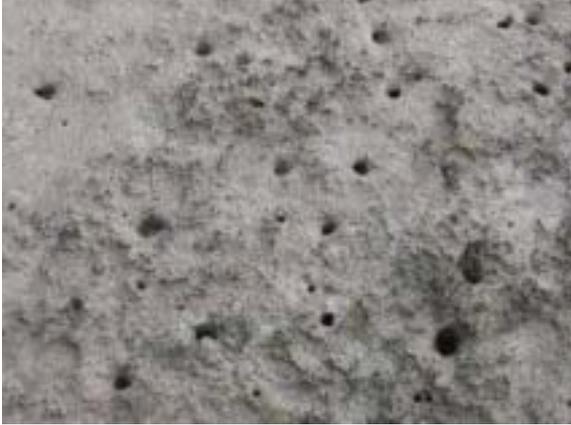
There were numerous crabs and crab holes across the entire mud flats, including the higher areas (Photograph 3 and 4).

**Photograph 3** Mud Flats adjacent to rehabilitated Freezing Works site at Patea showing numerous crab holes 5-8-10

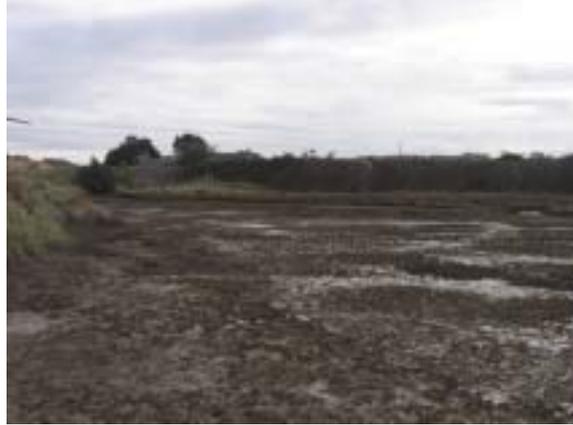
**Photograph 4** Mud Flats adjacent to rehabilitated Freezing Works site at Patea showing crab holes present throughout mud flat 5-8-10

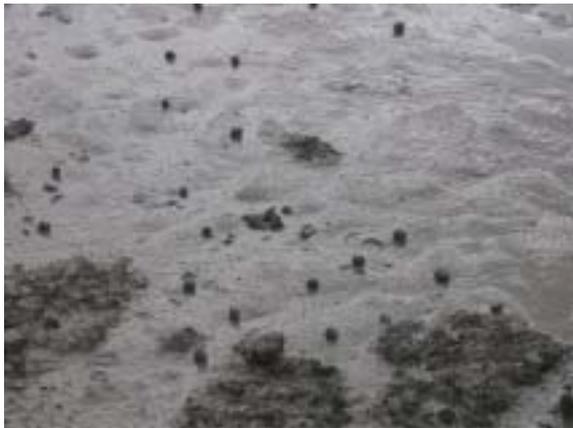
As in the previous two inspections, the mud snail, *Amphibola crenata*, was very abundant across the lower areas of mud flat (Photograph 5). Of note were healthy numbers of snails along the small streams leaving the Patea Freezing Works site (Photograph 6).

**Photograph 5** The mud snail, *Amphibola crenata* 5-8-10

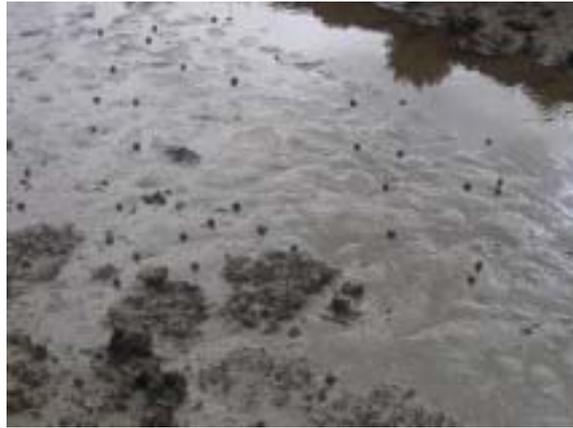
**Photograph 6** The mud snail, *Amphibola crenata* around streams from old site 5-8-10

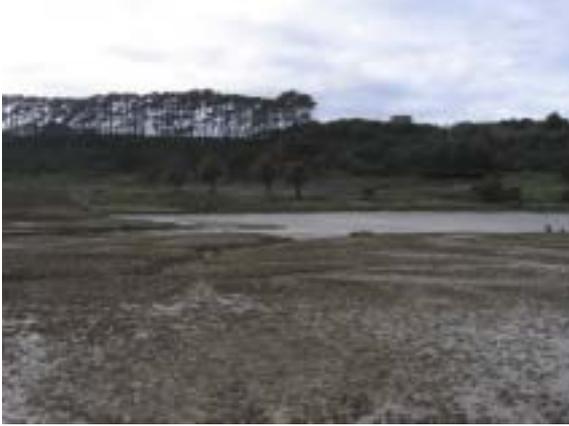
The trees and plantings growing around the edge of the mud flats also appear healthy and unaffected by any activities on the site (photograph 7 and 8).

**Photograph 7** Mud Flats adjacent to rehabilitated Freezing Works site at Patea showing growth of trees and plantings bordering site 5-8-10

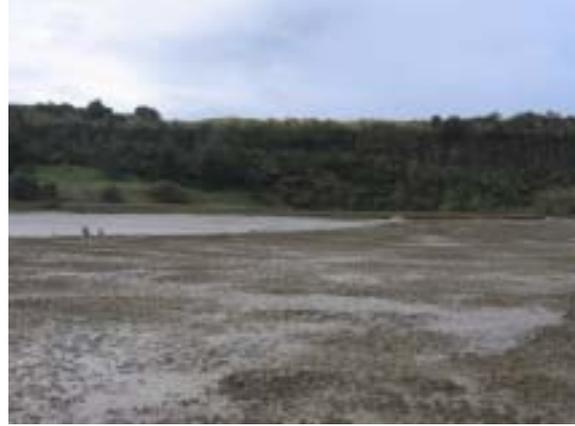
**Photograph 8** Mud Flats adjacent to rehabilitated Freezing Works site at Patea showing growth of trees and plantings bordering site 5-8-10

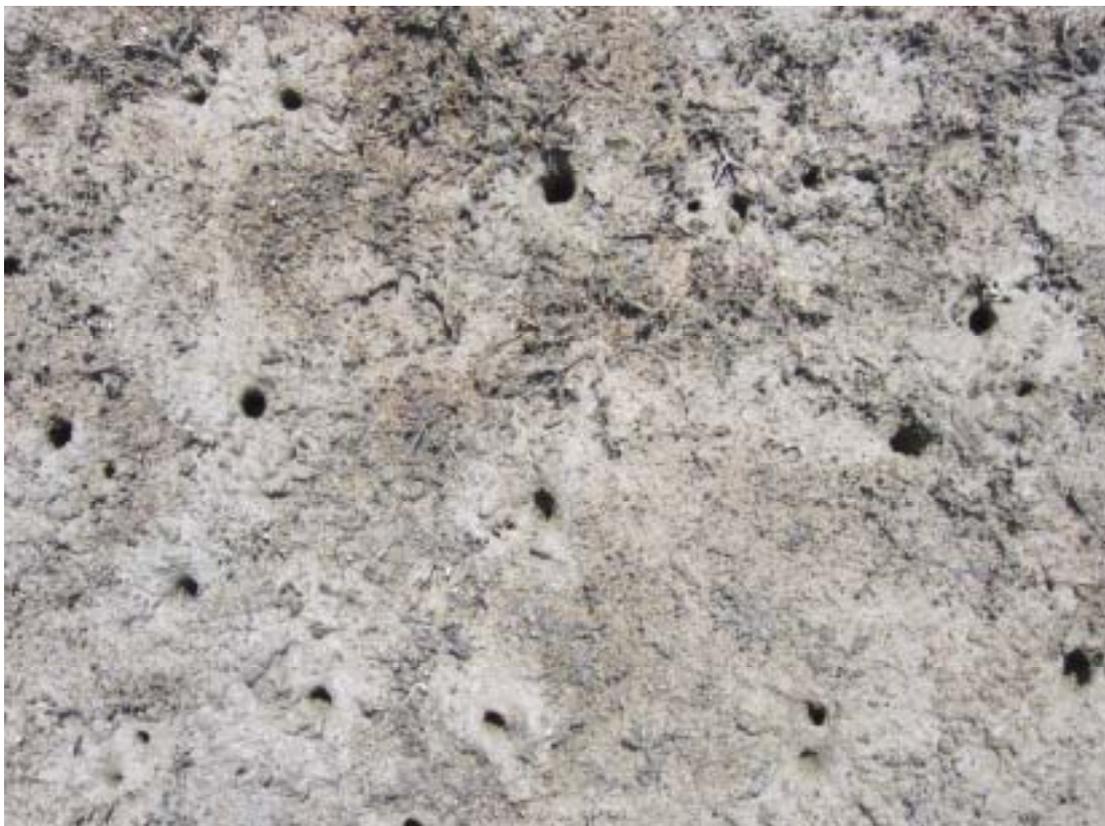
There were numerous crabs and crab holes across the entire mud flats, including the higher areas (Photograph 1).

**Photograph 1** Crab holes on mud flats

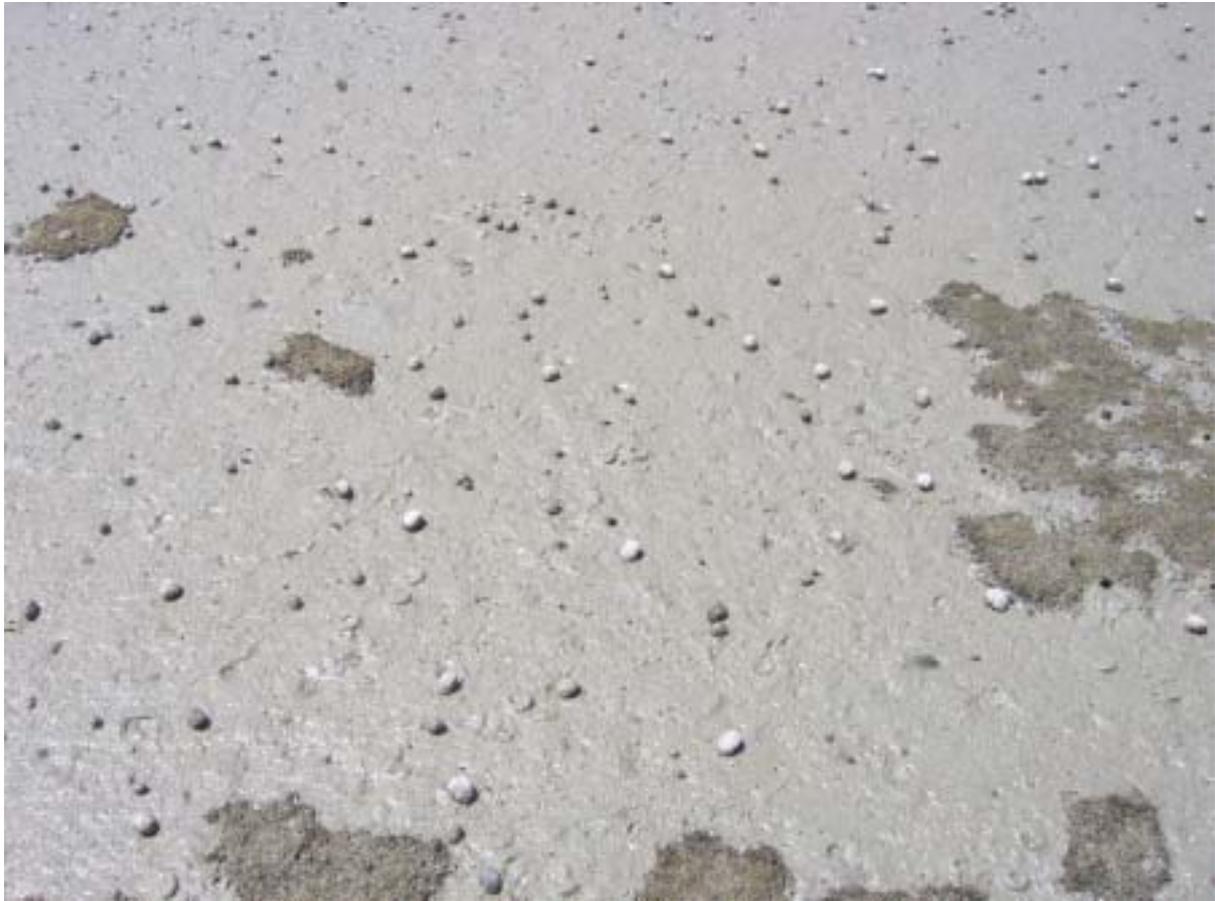
As in the previous inspection, the mud snail, *Amphibola crenata*, was very abundant across the lower areas of mud flat (Photograph 2). Of note were healthy numbers of snails along the small streams leaving the Patea Freezing Works site.

**Photograph 2** The mud snail, *Amphibola crenata*

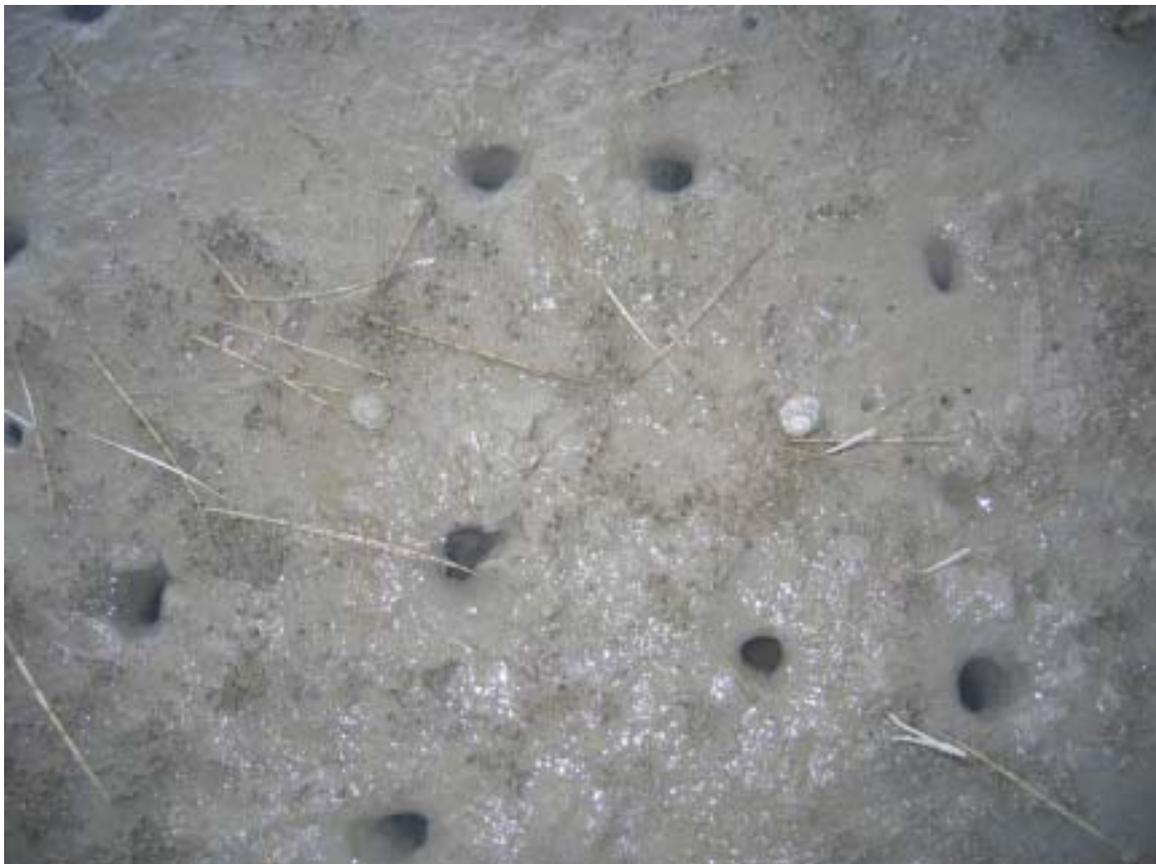
There were numerous crab holes across the entire mud flats, including the higher areas (Photograph 1).

**Photograph 1** Crab holes on mud flats

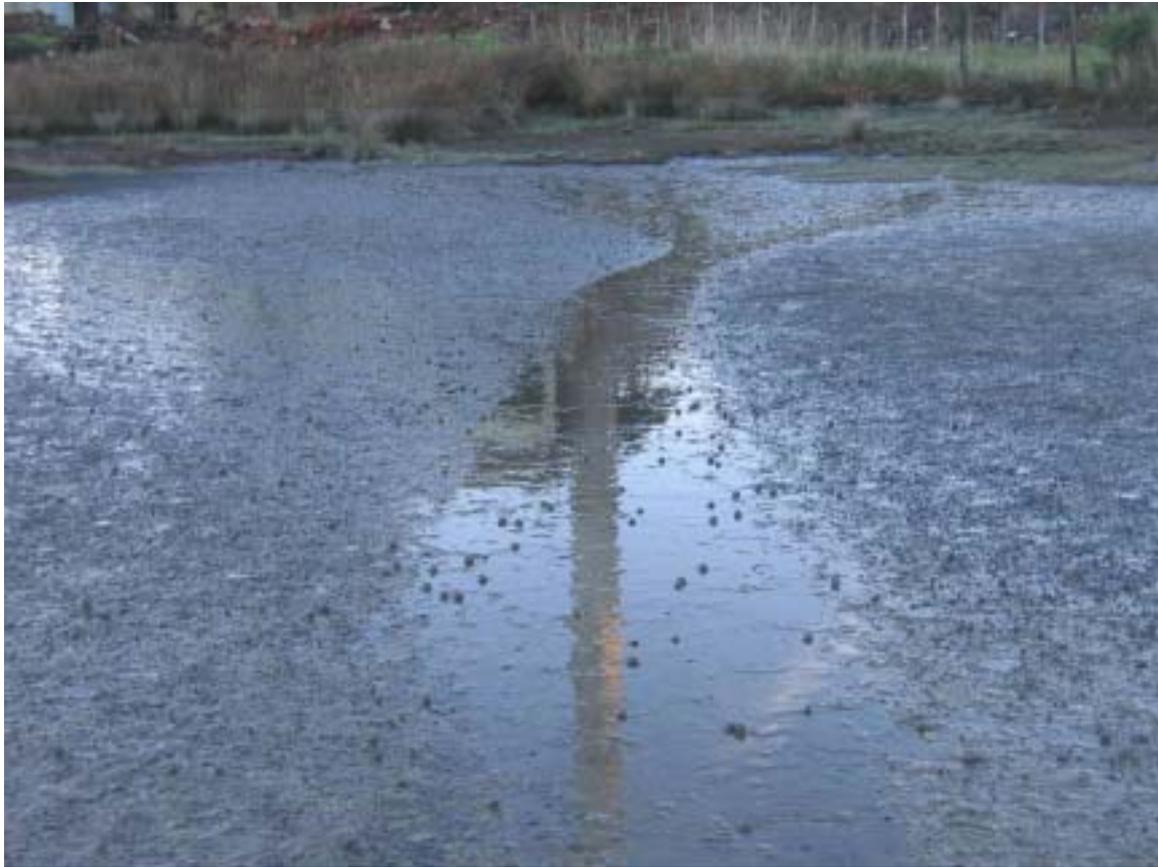
The mud snail, *Amphibola crenata*, was abundant across the lower areas of mud flat. Photograph 2 shows large numbers of the snails in one of the small streams leaving the Patea Freezing Works site.

**Photograph 2** The mud snail, *Amphibola crenata*
